# MASS MOVEMENT HAZARD AREA DEVELOPMENT

We would like to build a 40x40 ft cabin at our property. Also install a septic system.

| Site address:<br>21962 S Circle Diamond Lane Estacada Or 97023 | Comprehensive Plan designation:<br><b>R</b> | Zoning district:<br><b>FF-10</b> |

At your request, Strata Design, LLC (STRATA) completed a geotechnical investigation for the proposed development located at 21962 S. Circle Diamond Lane in Estacada, Oregon, as shown on the Site Vicinity Map (Figure 1). The purpose of this report is to present the results of our investigation and provide geotechnical design and construction recommendations in general accordance with Clackamas County requirements for development in areas of potential geologic hazard.

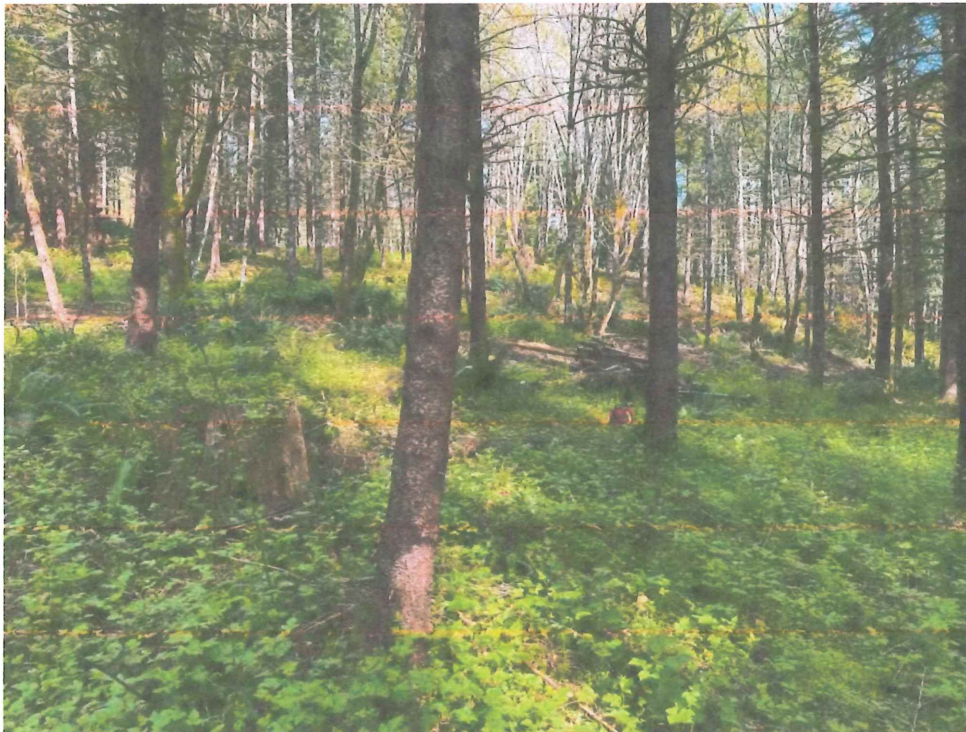
The area above the proposed cabin consists of a moderately inclined forested slope with mature coniferous trees, dense understory vegetation, and a well-developed organic surface layer. The slope is generally uniform and well vegetated, with no evidence of concentrated runoff, gullying, or erosion. Photo 1 shows typical conditions in the upslope area. Below the proposed cabin, the ground surface descends toward the existing gravel access road. This area is more open and consists of grass cover, scattered trees, and isolated areas of exposed soil. The slope geometry is generally uniform, and no evidence of active erosion or slope movement was observed during our site visit. Photo 2 shows typical downslope conditions.

*Photo 1 View looking upslope showing moderately inclined, forested terrain with mature coniferous trees, dense understory vegetation, and well-rooted surface soils. No visible signs of instability such as scarps, tension cracks, or erosion features.*

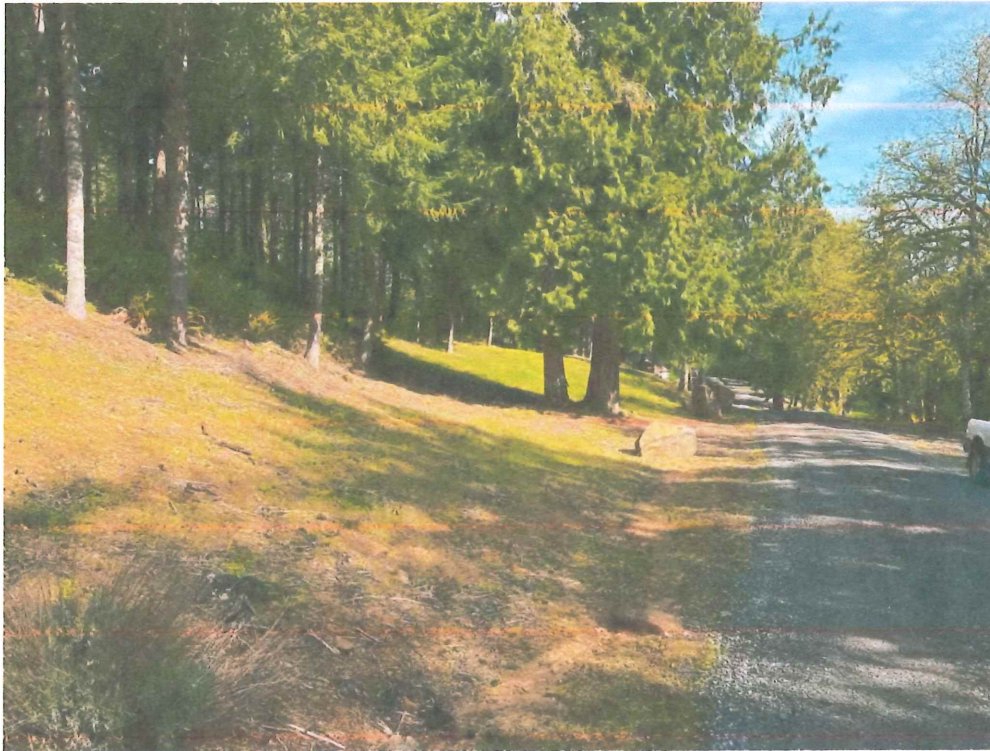
*Photo 2 View looking downslope toward access road showing gently to moderately sloping terrain with grass cover, scattered trees, and localized exposed soils. Slope appears uniform and stable with no evidence of active erosion or slope distress*

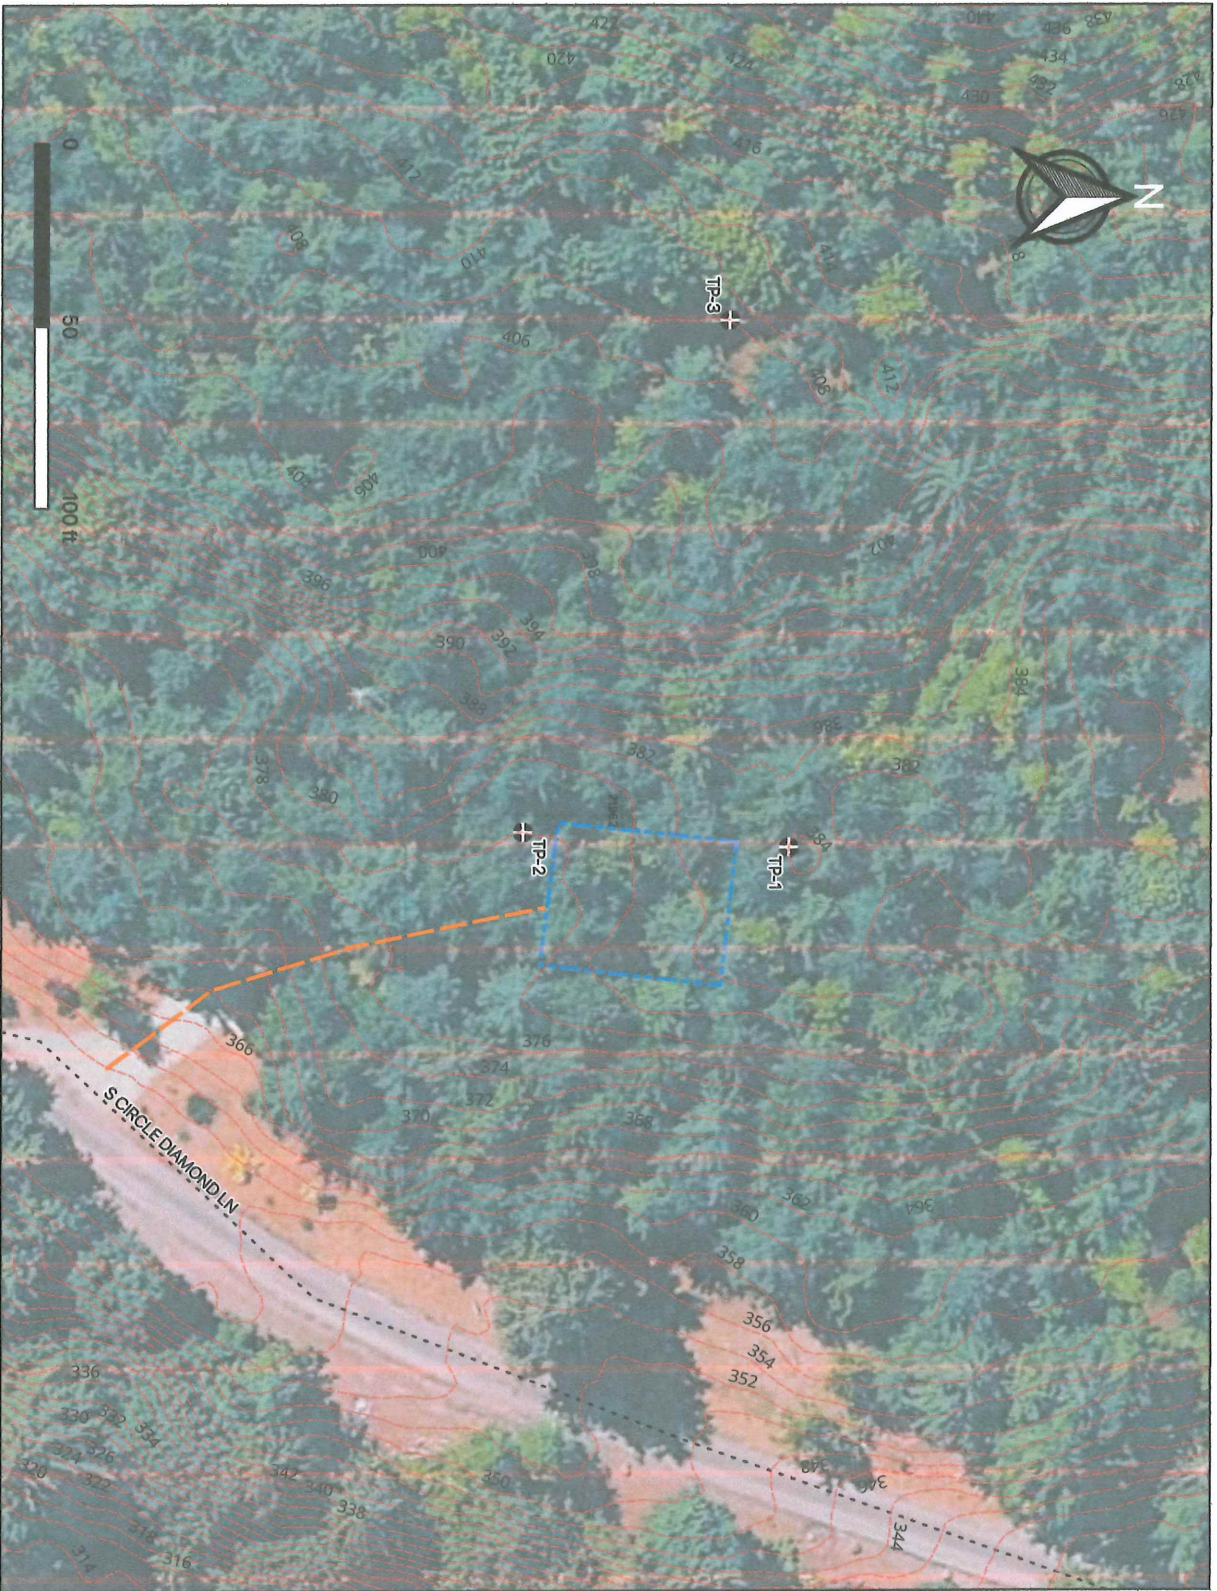
**Figure 2**

On April 10, 2026, STRATA conducted a geotechnical investigation at the Site consisting of three test pits (TP-1 through TP-3) excavated to depths ranging from approximately 8 to 9.5 feet below ground surface (bgs). The test pits were excavated using an excavator, and the purpose of the investigation was to evaluate subsurface conditions in support of the proposed cabin, including foundation support, slope stability, and general constructability. Test pit locations were selected to evaluate the proposed building footprint and representative site conditions across the property. The approximate locations of the explorations are shown on Figure 2. Detailed logs of the soil explorations are provided in Appendix B.

Subsurface conditions encountered during the investigation generally consist of approximately 1 foot of topsoil overlying moist, medium stiff lean clay with sand extending to depths of approximately 2.5 to 3 feet. These fine-grained soils are underlain by granular colluvial materials consisting of silty sand, clayey sand, and gravel with increasing cobble content with depth. In deeper portions of the test pits, particularly in TP-3, very dense granular soils containing cobbles and occasional boulders were encountered, resulting in increased excavation resistance and localized refusal on larger fragments. These materials are interpreted as dense colluvium or highly weathered volcanic rock and are suitable for bearing support when properly exposed and evaluated.

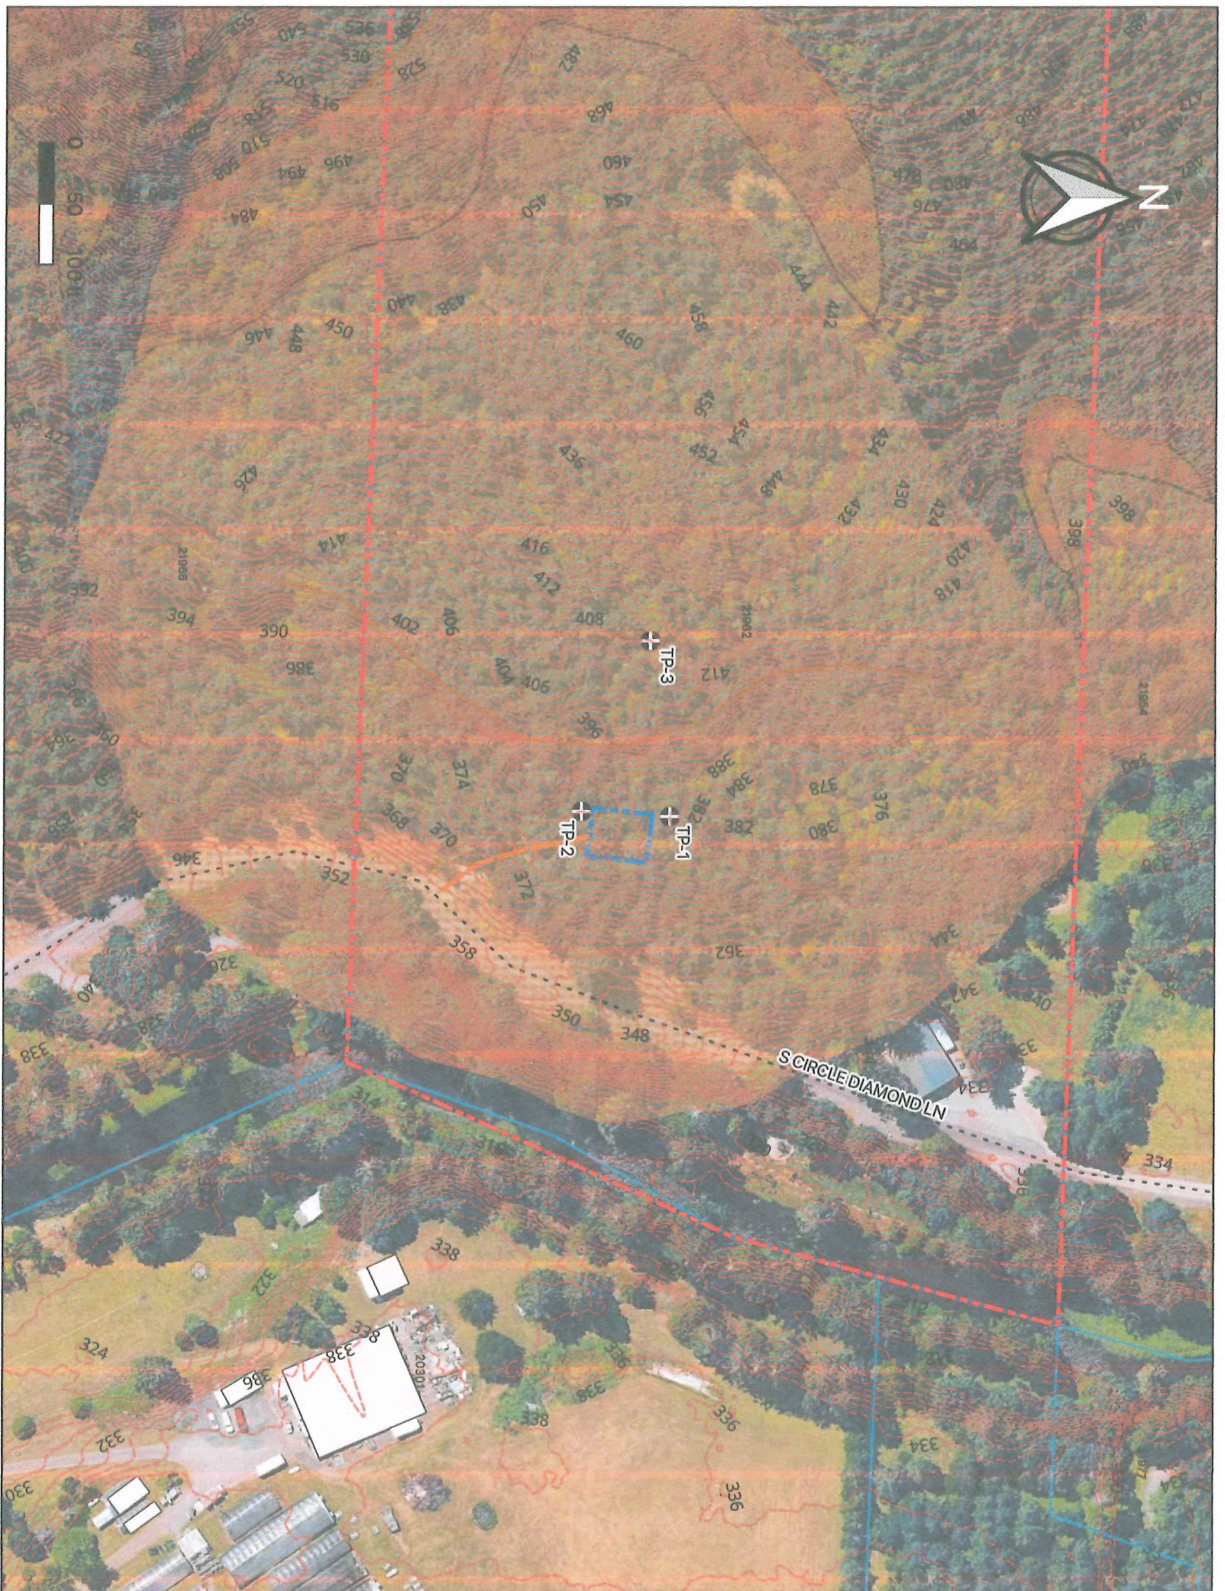
**Figure 3**

Regional geologic and mapped landslide hazard features in the vicinity of the site are shown on Figure 3. The project site is located within DOGAMI Statewide Landslide Information Database for Oregon (SLIDO) inventory feature Redland\_186. The mapped feature consists of a broad, mature landslide landform exhibiting characteristics of a long-stabilized relict landslide deposit. The landform is characterized by subdued topography, extensive weathering, mature vegetation, and evidence of long-term geomorphic stability. Although DOGAMI classifies the feature as a mapped historic complex landslide inventory feature and assigns it a high confidence rating, field reconnaissance, LiDAR review, and subsurface explorations indicate that the mapped feature has undergone substantial weathering, erosion, and revegetation over an extended period of time.

Based on the observed geomorphic characteristics, degree of weathering, subdued topographic expression, mature vegetation, and regional geologic history, we surmise that the mapped landslide feature may have formed, or last experienced significant movement, during the late Pleistocene to early Holocene geologic timeframe. Accordingly, the feature is interpreted to be at least several thousand years old and potentially associated with landscape adjustments that occurred following repeated Missoula Flood events and other post-glacial geomorphic processes affecting the region. In addition, catastrophic

Review of available LiDAR imagery, topographic mapping, aerial imagery, and field observations indicates that the mapped landslide feature consists of a broad, mature landslide landform that has undergone substantial weathering, erosion, and revegetation. Distinct geomorphic indicators typically associated with active landsliding, such as fresh scarps, tension cracks, active seepage zones, hummocky ground, displaced vegetation, or evidence of recent slope deformation, were not observed within the proposed development area.

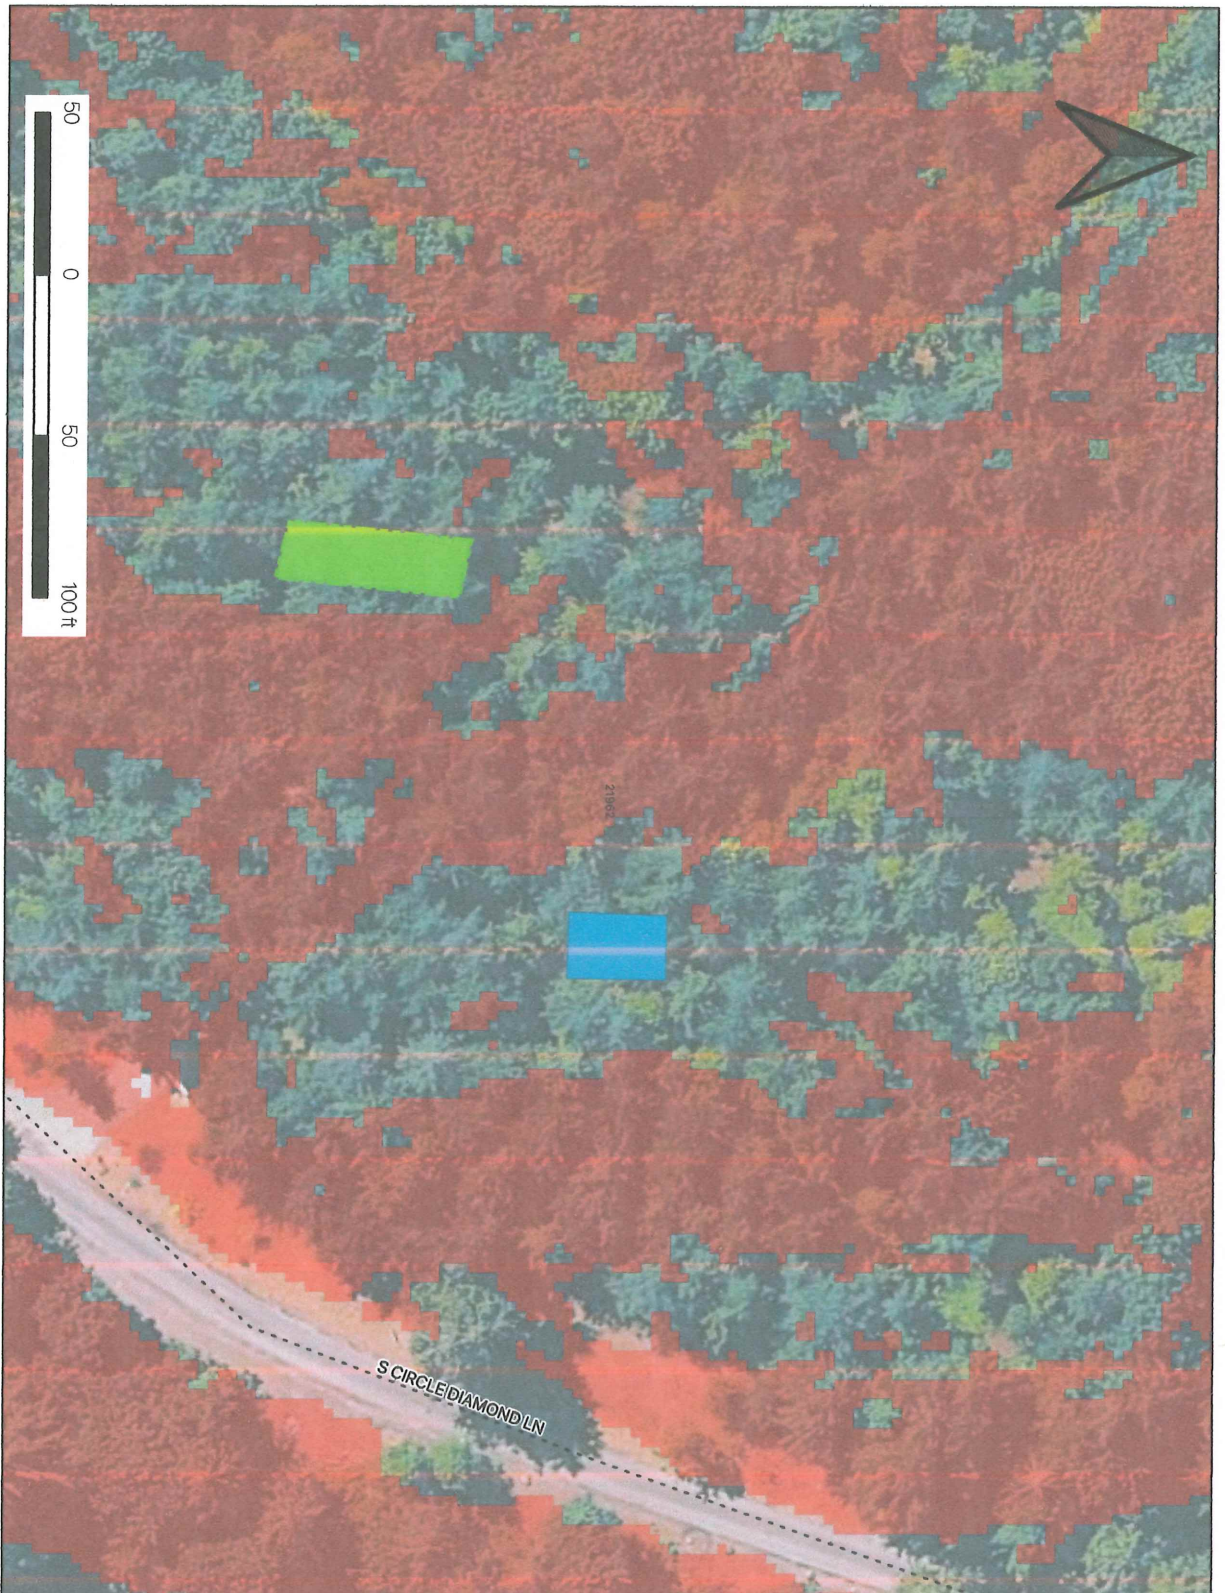
**Steep Slope Areas ( $\geq 20\%$  Slope)**

As shown on Figure 4, slopes exceeding 20 percent occur throughout portions of the property and surrounding hillside. The proposed cabin and drainfield are located within a relatively gentle bench area that was specifically evaluated as part of this geotechnical and landslide hazard investigation.

STRATA recommends maintaining a minimum horizontal setback of 20 feet from the crest of the primary downslope area for all structural elements. Where practical, additional separation from slope breaks is beneficial. Surface water should be directed away from slope areas, and concentrated runoff should not be discharged over slope faces, toward slope crests, or into areas where infiltration could adversely affect slope stability.
