**NOTICE OF LAND USE APPLICATION IN YOUR AREA**

**File Number:** Z0081-24

**Proposal:** A replacement dwelling within a mapped landslide hazard area. Development on mapped landslide hazards is regulated pursuant to ZDO Section 1003.02.

Rapid Soil Solutions Inc (RSS) has prepared this geotechnical report, as requested, for the proposed construction of a new single-family residence on the Clackamas County tax parcel currently assigned the street address of 21121 S Redland Rd (Oregon City, OR 97045). The 7.22-acre lot contains the derelict remains of a small residential structure and a small detached structure; the foundations of both structures remain on site, both foundations are obscured by the collapsed/demolished debris of the structures. RSS understands that the new development will utilize the existing disturbance area, possibly extending beyond the footprint currently impacted by historic grading and development. The majority of the property contains irregular slopes with a moderate to dense tree canopy.

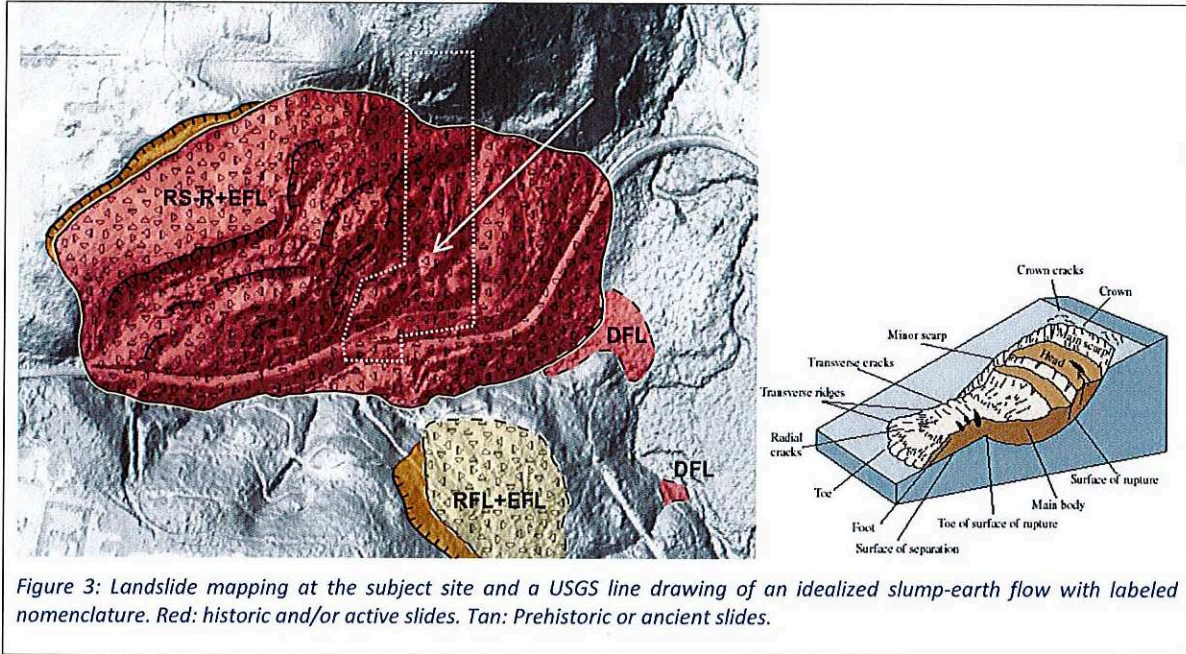
Fine-scale, lidar-based, landslide mapping indicates that the subject site is located within a deep-seated landslide. This slide has moved in the past 150 years. It contains numerous internal scarps in addition to the head-scarp. The proposed disturbance area is located within the main body of the landslide, directly below the lowest set of mapped internal scarps.

Detailed landslide modeling includes a moderate to high susceptibility in regards to shallow seated landslides. The site is assigned a high susceptibility to deep-seated slope failures.

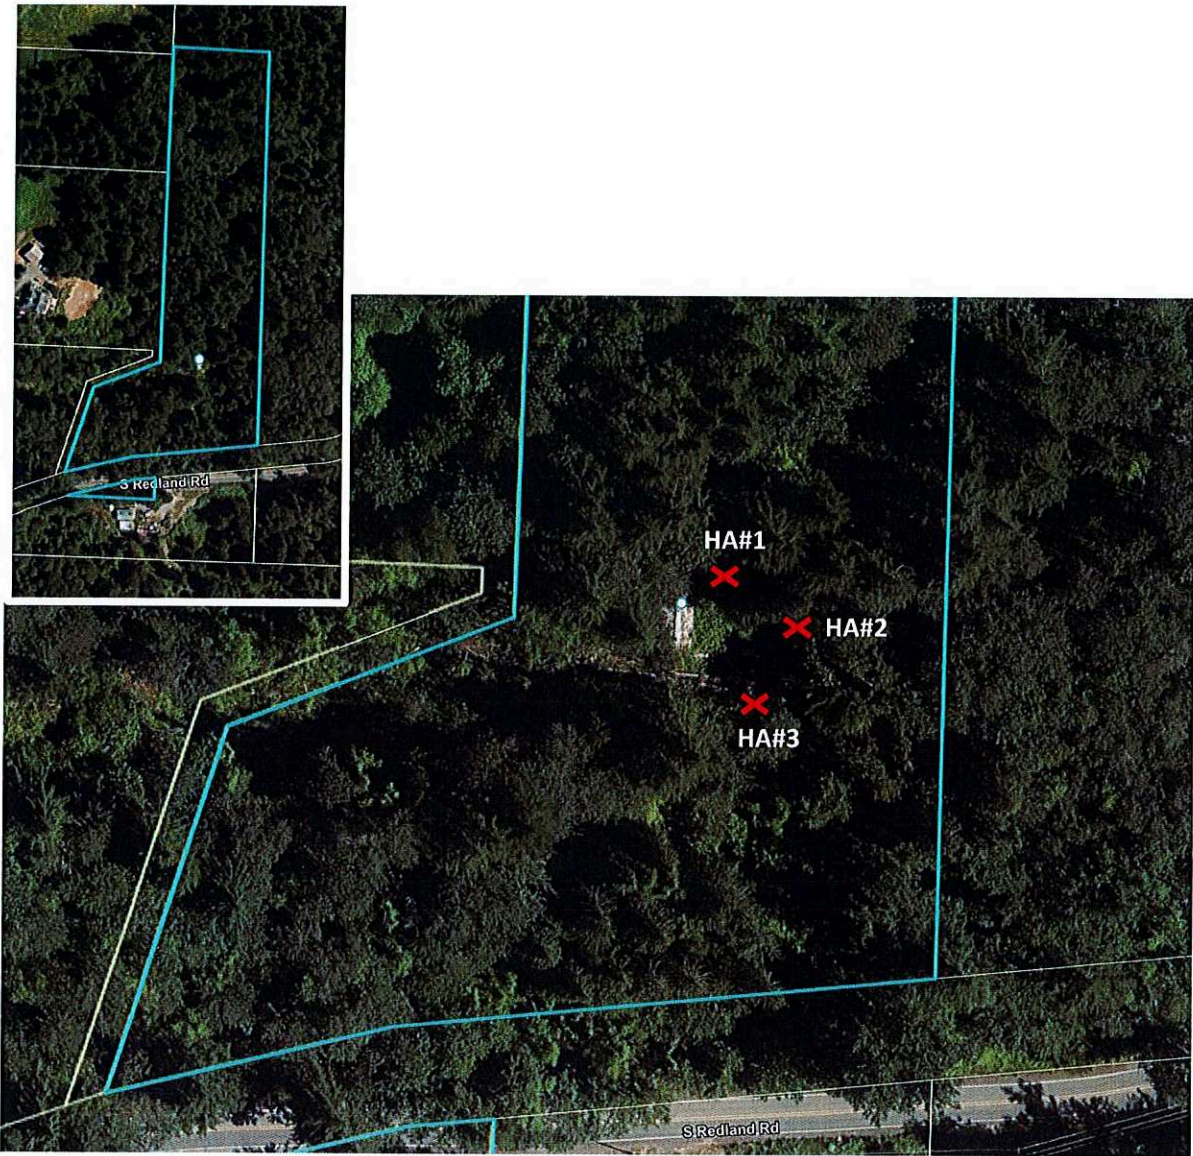
Figure 2: Subject site with 2022 aerial imagery from Cmaps and approximate boring locations

A total of three (3) shallow hand auger borings were conducted at the subject site. The locations are shown in the Appendix. RSS encountered shallow refusal in two of the three hand auger borings. The shallow subgrade contained basalt gravels and cobbles in silt and/or clay, poorly consolidated siltstone and sandstone, as well as the high plasticity weathering product of a fine-grained sedimentary rock. The subsurface conditions appear consistent with the local sedimentary bedrock and overlying basalts, which have been mix and moved by slope failures.
